XK150 boot-lid mounted high brake light replacement

Simon Crispe

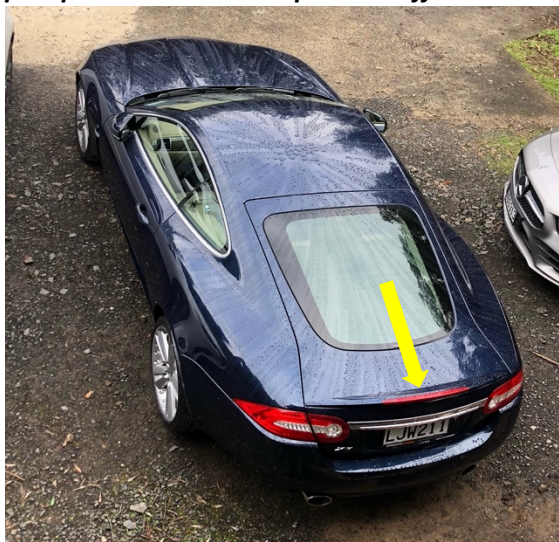
Having just had my "new to me" 2011 XK 5.0 Portfolio serviced by the friendly folk at Archibald & Shorter Greenlane, I noted their observation that half the rear spoiler LED brake lights had failed. At \$650 + GST, I felt my first attempt at fixing a "modern" Jag was justified. After all, how hard could it be...to paraphrase a certain Top Gear buffoon!??

i) Failing boot spoiler mounted LED brake light.

First I ordered part no. C2P14783 from SNG Barratt in the UK. A special order was required and they promised it would be with me in three weeks. Cost \$275 incl. shipping. They under promised and over delivered as pleasingly, the new LED arrived two weeks later.

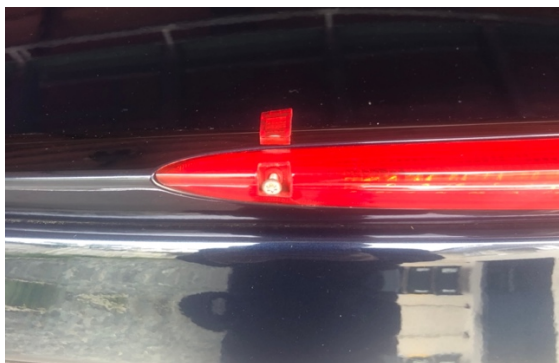
ii) Easily removed cover clip over torx screw.

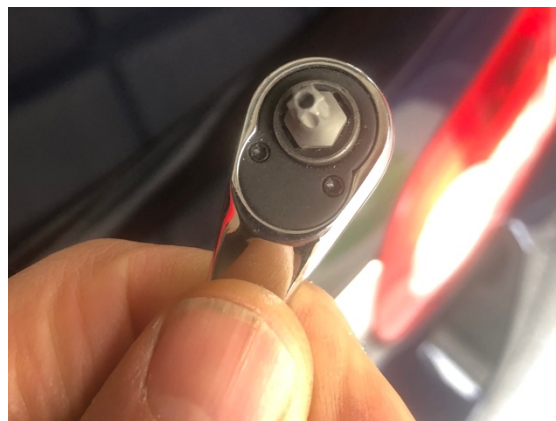
iii) Two Torx/star head screws easily removed with the correct screw bit.

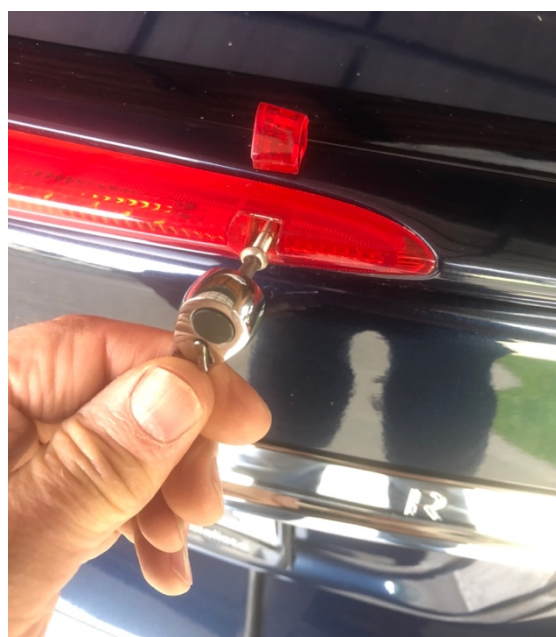
iv) removing LED unit fixing screws with torx ratchet

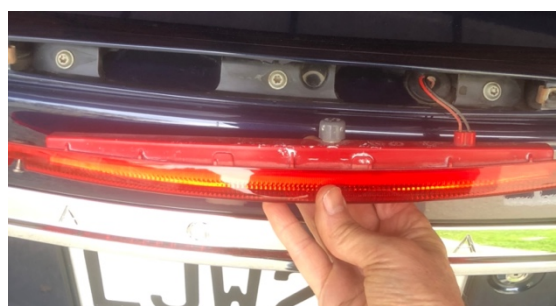
v) That went well and the lamp unit released after a gentle pull. Note the red and black cables

After releasing the old LED, (see photos iii), iv) & v) it all got rather more complicated. There was no quick release cable plug I had hoped would be visible and easy to uncouple. The red and black cables disappeared off into a cavity below the composite spoiler into the alloy boot

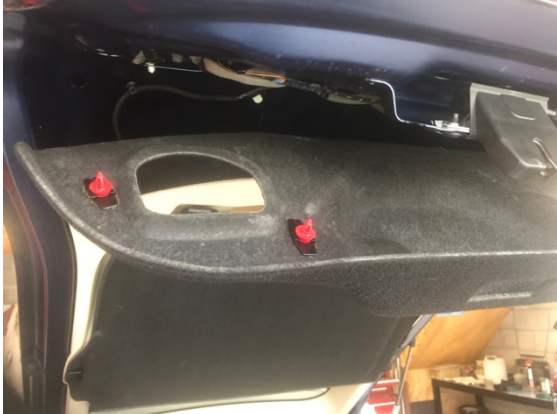
vi) Left hand side trim clips removed.

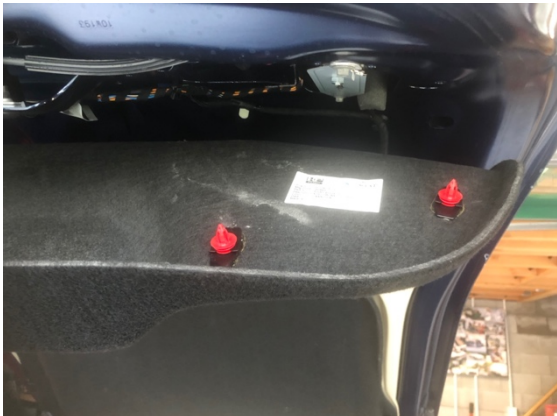
vii) Right hand side trim clips removed.

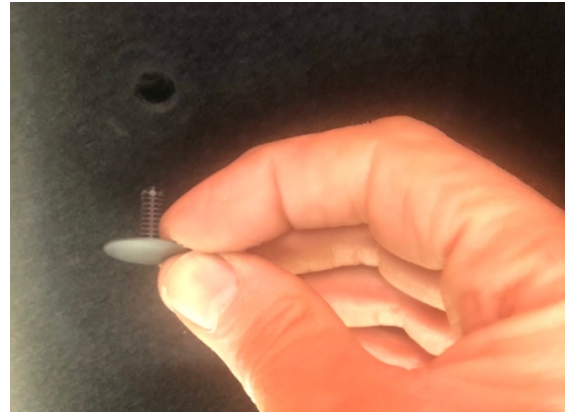
However, there are two more clips that are of the visible type which release the rear centre section of the trim panel. These are a mushroom shape with serrated shanks that press into two holes in the inner alloy boot lid panel. (see photo ix).

ix) mushroom clip fixings for rear centre trim panel

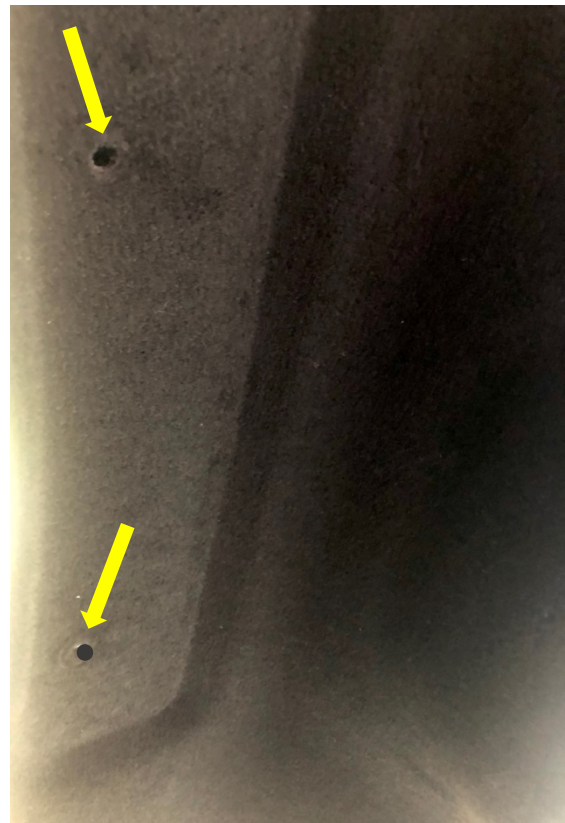
x) rear centre clips removed

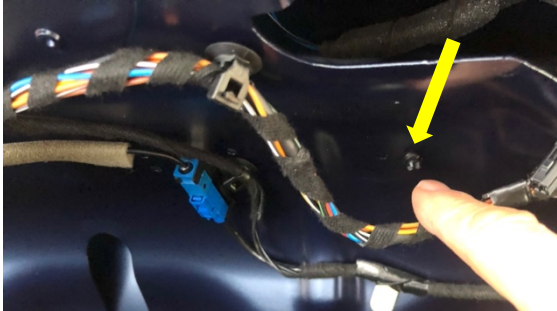
I fully expected to find a readily visible “plug and play” set up to release the LED from inside the boot panel, but this was not to be. Instead, I found an intermediate cable connection that links the two cables from the LED unit to the rest of the main boot loom. This intermediate cable was attached to the inner alloy panel of the boot lid with another mushroom clip and zip tie. See photo xi). The only way I could release the intermediate loom was to gently

xii) end of mushroom clip holding intermediate loom

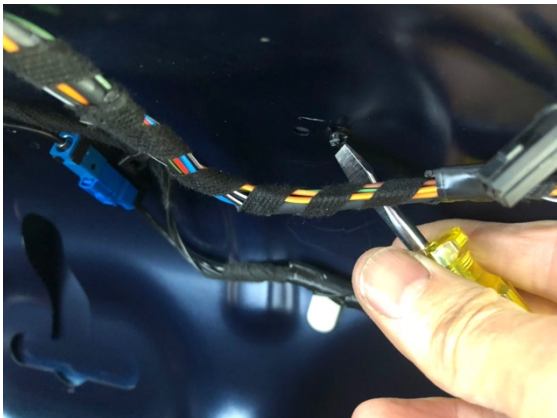
xii) Pressing end of end of mushroom clip holding intermediate loom, back through boot lid inner panel

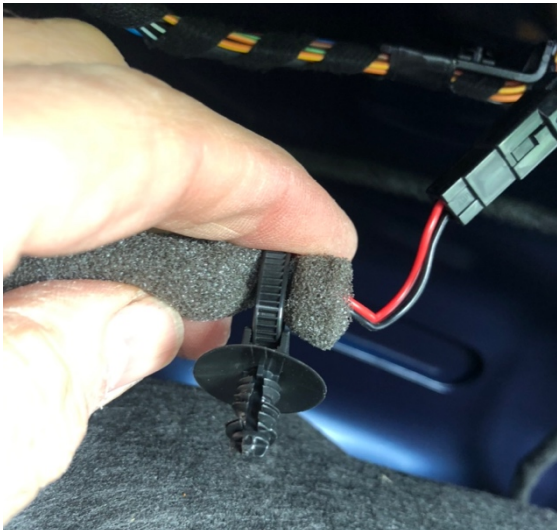
xiii) released mushroom clip and intermediate loom (foam wrapped). Note cable connector clip at top right of frame.

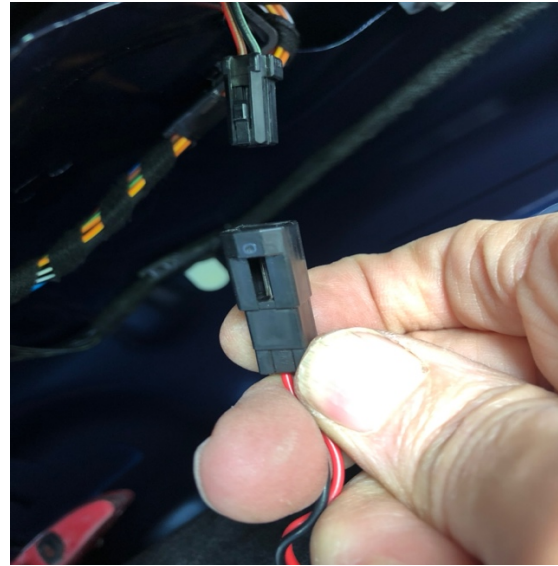
xiv) cable connector releasing intermediate loom

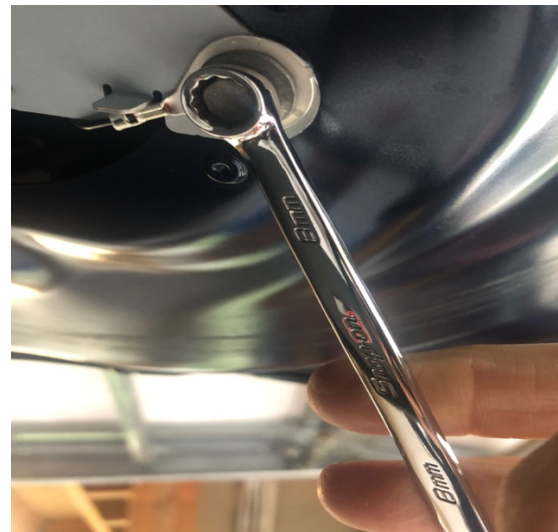
xv) releasing earth cable of intermediate loom

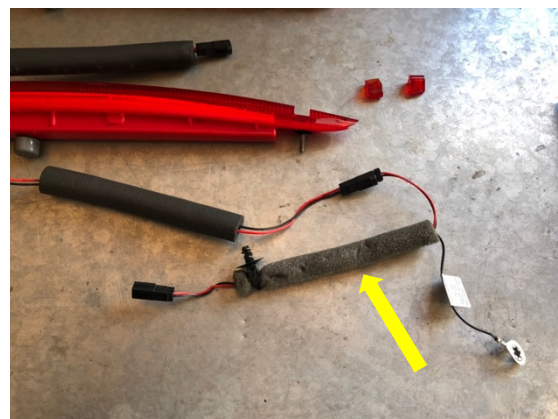
xvi) old LED removed with intermediate cable (arrowed)

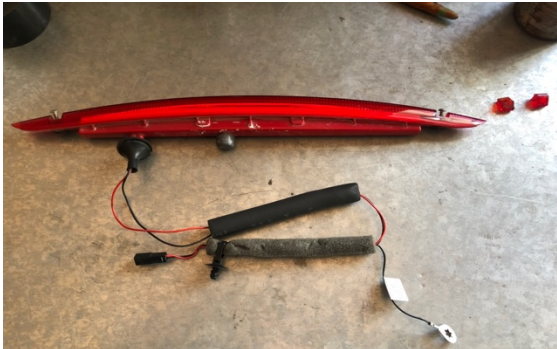
xvii) new LED unit connected to intermediate & earth cables.

The next step was to remove the intermediate cable from the old LED unit and reconnect it to the new one. (See Photo xvii).

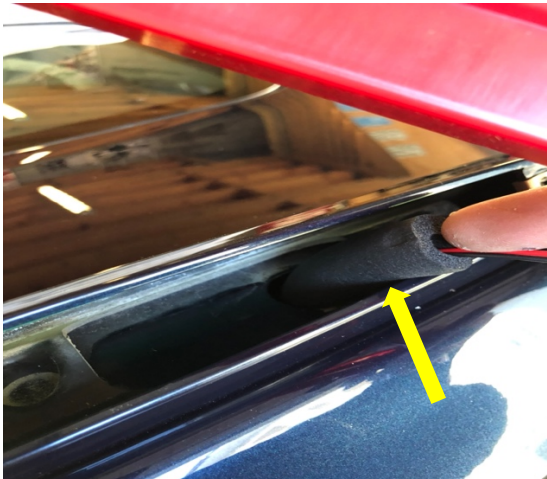
xviii) new LED cables fed back through boot spoiler

I then fed the intermediate cable connected to the new LED back through the boot lid spoiler into the boot lid cavity below. (See Photo xviii)

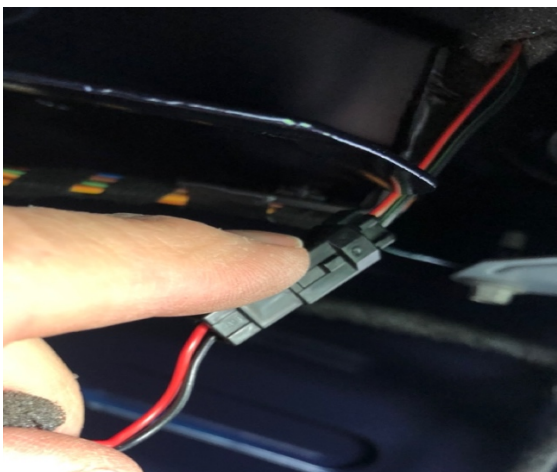
xvix) intermediate loom reconnected to main boot loom

I reconnected the intermediate cable to the main boot lid loom and refitted the mushroom

loom retaining clip into the inner boot lid panel. This was quite finger punishing to get my hand in between the inner and outer alloy panels of the boot lid so as to press the head of the mushroom clip back in. Then followed the reconnection of the earth cable and 8mm set screw.

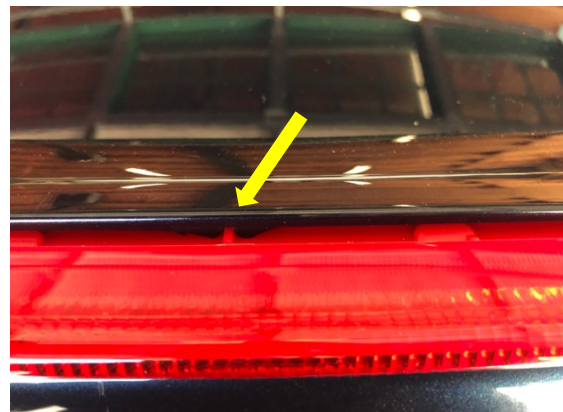
I semi closed the boot lid without latching it so as to refit the LED unit to the spoiler lip. This was not quite as straightforward either! There is a tiny acrylic alignment peg on the inside of the LED unit (see arrowed photo xx) that aligns with a small slot in the composite spoiler moulding. These two alignment points need to be positioned correctly as the two star head screws are re-tightened to bring the LED up tight onto the spoiler. This needs to be done with real care to avoid damaging paintwork or the plastic parts. I used some masking tape on the paint around where the fixing screws are located to ensure any slips did not cause damage.

xx) alignment peg on new LED
