Early 3.8 E Type petrol leak!

Simon Crispe

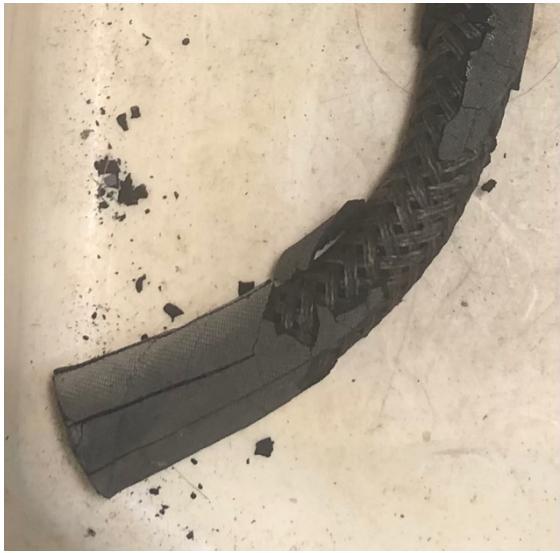
A day later, I went back into the garage to discover an very strong smell of petrol. I quickly opened all the doors and windows, after finding a large pond of fuel under the rear of the car. To my horror, I found lots of fuel bubbling up around the 12V power cable into the fuel tank that powers the submersible pump inside the tank. Petrol was pouring out through the fuel tank sump aperture in the boot floor!

After draining a few litres of fuel off via the glass fuel filter bowl connection in the engine bay and disconnecting the battery, I removed the Lucas 2FP submersible fuel pump. I found that the flexible, mesh covered, rubber power cable conduit (meant to form a sealed electrical connection into the pump), had completely disintegrated and was allowing the fuel in the tank to capillary vertically upwards via the electrical cable, out of the tank.

Disintegrated rubber conduit (new when installed in 2015) – Ethanol damage possibly?

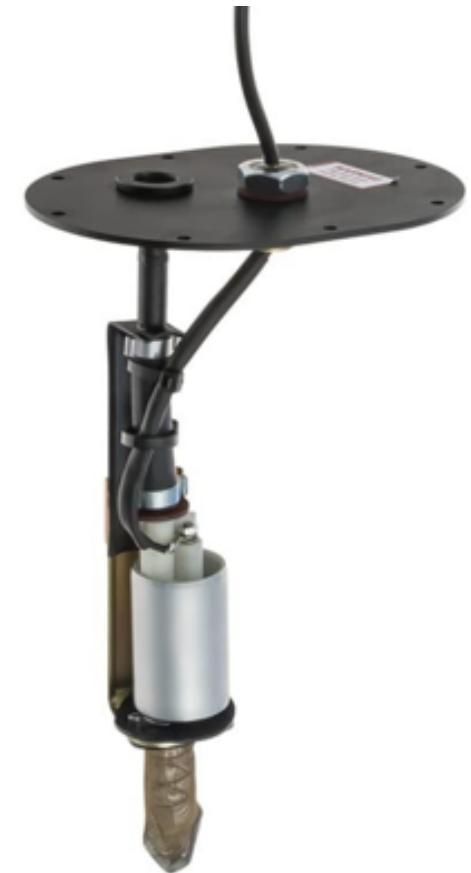
Upgraded, simplified replacement in tank pump The car started easily and we were off, roof down and with cool dense air the engine just purred.

However, upon reflection, I decided to leave this original artifact on display as a point of interest and ordered one of the upgraded SNG Barratt (UK) replacement in-tank pumps. The new pump fits exactly as per the original and when viewed on the outside of the tank, looks identical to the original.

There it was in black and white... "Ensure No. 6 fuse is uprated to 7.5A upon fitting" (i.e 7.5amps continuous /15amps blow).
