XK Heater Valve rebuild

Simon Crispe

Having noticed an annoying pool of anti-freeze green coolant under the XK, I decided to investigate the source of the leak and discovered a weeping heater valve.

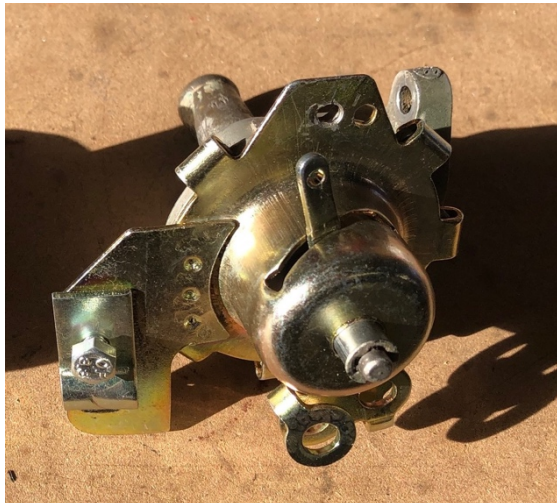
1) Passivated zinc replacement valve; also no part No.

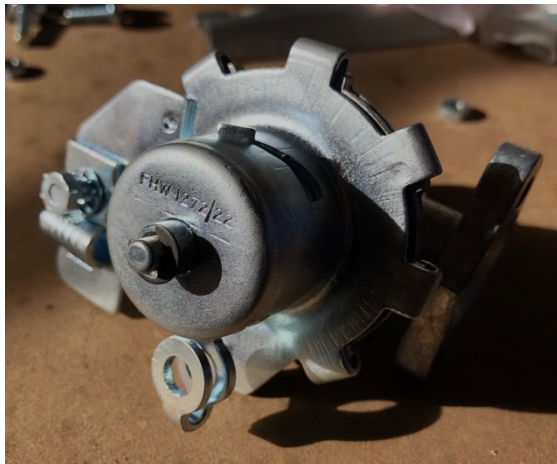
2) Original valve: zinc plated & Part No. FHW 1272/22

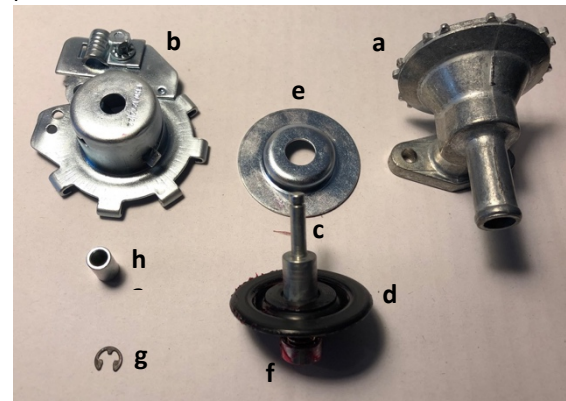
3) Original & replacement valve components

There is a small pop rivet that holds the zinc plated outer housing onto the alloy valve body. Drill out the pop rivet on both the new and original valve. Then, remove the little circlip from the projecting centre spindle on each valve. Once these parts have been removed, you will be able to turn the outer zinc plated casing so as to release the outer casing from the alloy tabs on the alloy valve body.

This will reveal similar internal rubber and metal components in both valves including:

- Alloy valve body
- Outer zinc plated housing
- Centre spindle
- Attached rubber diaphragm located in a groove machined in the spindle
- Zinc plated disc that sits over the spindle and diaphragm
- Rubber cup seal that sits over the inner end of the spindle and engaged in the seat at the bottom of the alloy housing
- Circlip
- zinc plated inner distance tube that sits between the activating lever and the shoulder of the centre spindle.

Care needs to be taken to ensure you take note of exactly how each valve comes apart and reassembly must be the reverse of the dismantling process. See Photo 3.

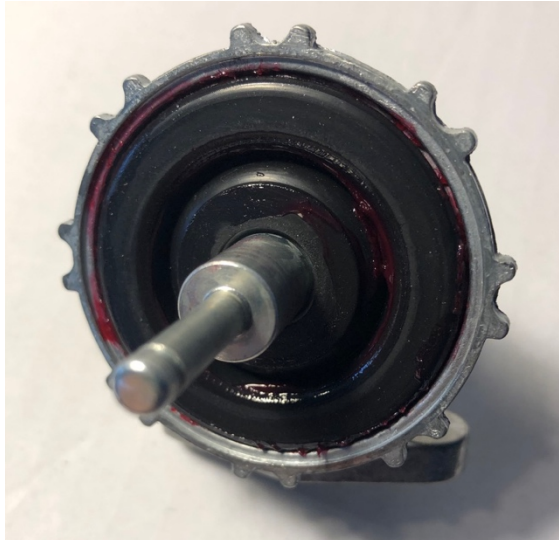
The original valve was leaking because of a tear in the perished diaphragm. The diaphragm in the new valve and the new valve spindle were identical to the old valve, so these were inserted into the new valve body after being liberally coated with rubber grease. The internal zinc plated disc is now installed over the diaphragm. Photos 4 & 5

4) New rubber diaphragm (d) inserted into new alloy valve body a). Note liberally applied rubber grease.

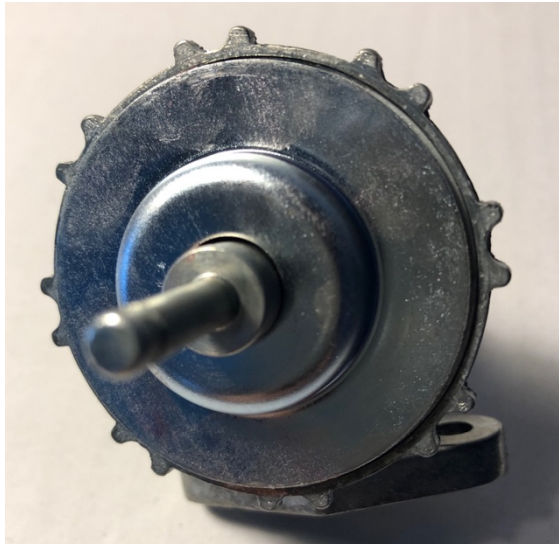
5) Zinc plated disc e) that sits over the spindle c) and diaphragm d) on valve body a).

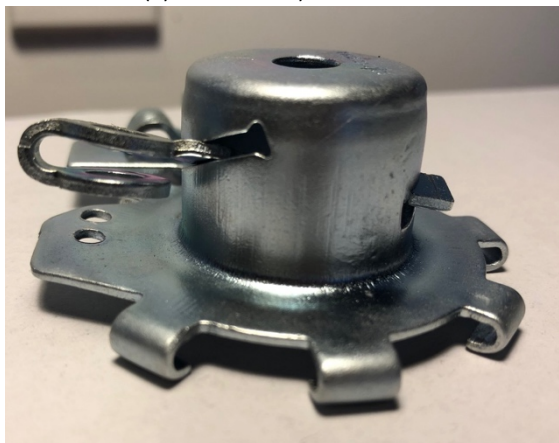
6) Zinc plated activation lever inserted into outer casing

The activation lever from the original valve was re-plated and re-used. It needs to be inserted along with the distance tube (h). See Photo 6).

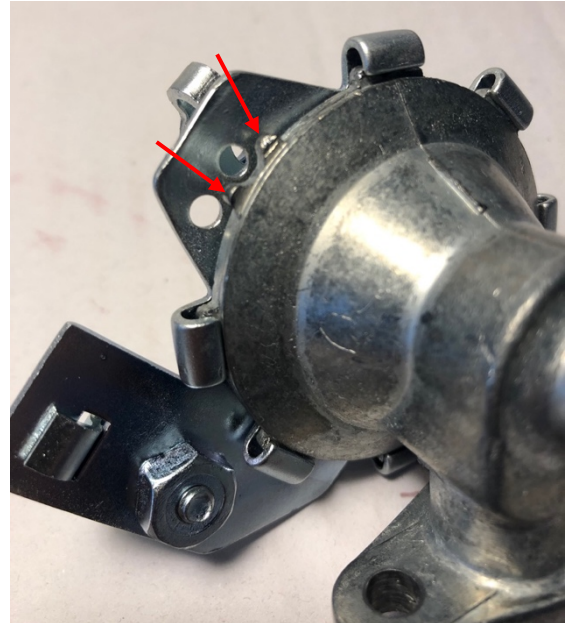
7) Re-plated outer housing b) installed onto new alloy valve body, with pop rivet holes aligned.

Align the alloy housing tabs with the gaps in the outer casing. Turn the casing until it engages on the alloy housing tabs. Make sure the pop rivet hole in the casing is aligned with two projections (arrowed on photo 7) on the cast alloy housing and install pop rivet.

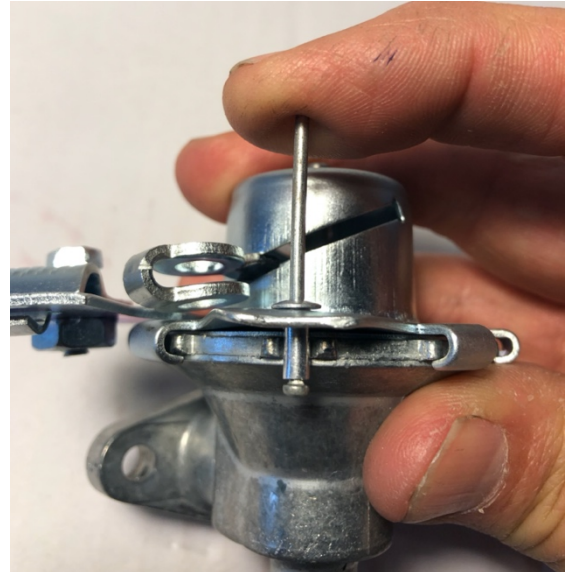
8) pop rivet inserted into aligned hole through outer casing and two small projections on alloy valve body.

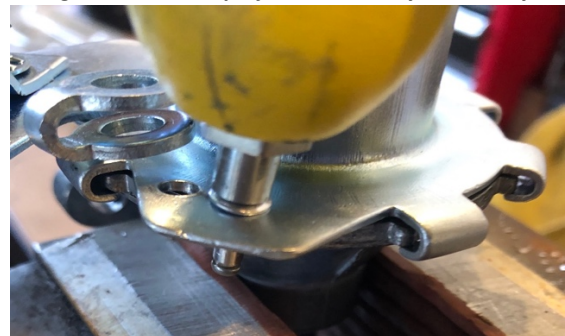
9) pop rivet fastening

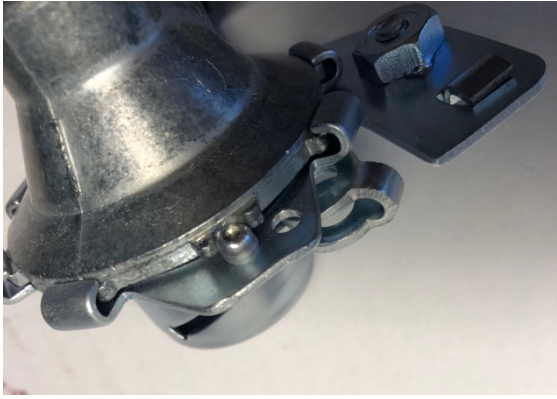
10) installed pop rivet

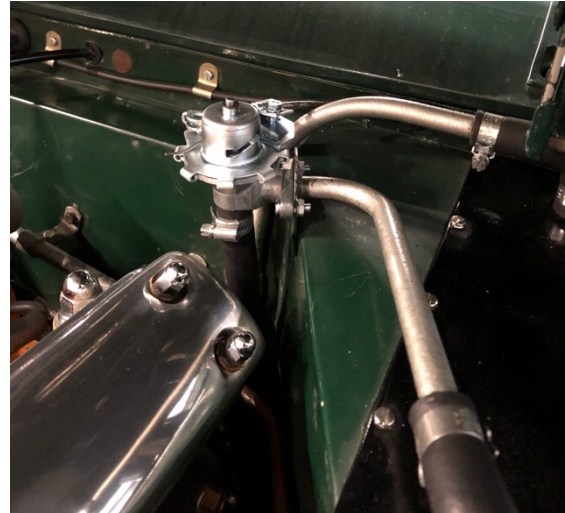
11) installed reconditioned valve.

Reinstall valve onto heater, reconnect heater hoses and control cable. See Photo 11)
