Warren Tait's '69 E-Type S2 story – Stage 2

Overhaul of the Independent Rear Suspension IRS

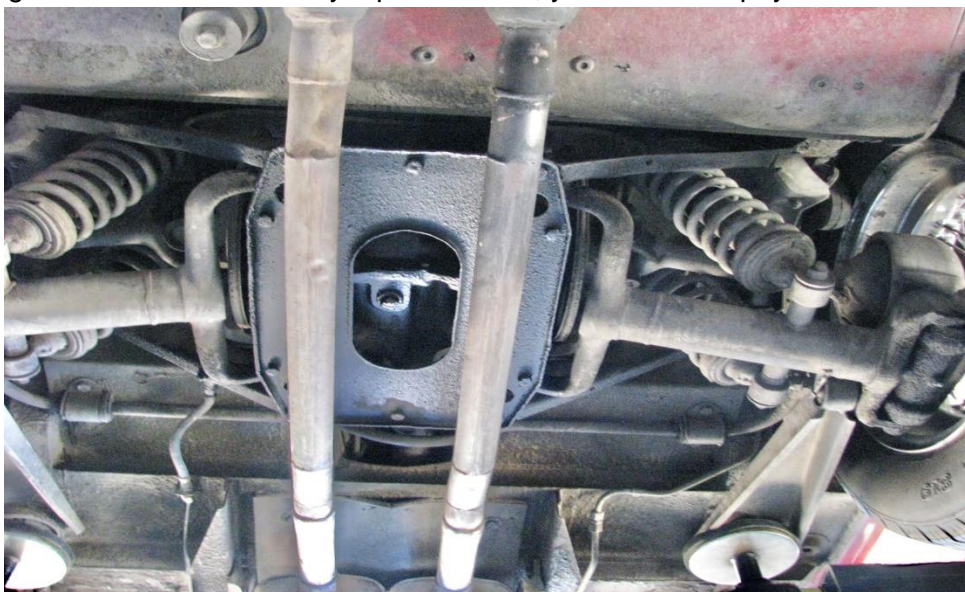
The first job was to drop the exhaust system. This was another example of a very poorly executed job on this car, which would be a complete throwaway. The welding, the bends, everything about it was just a nightmare. If it was done by a professional, you would not pay them!

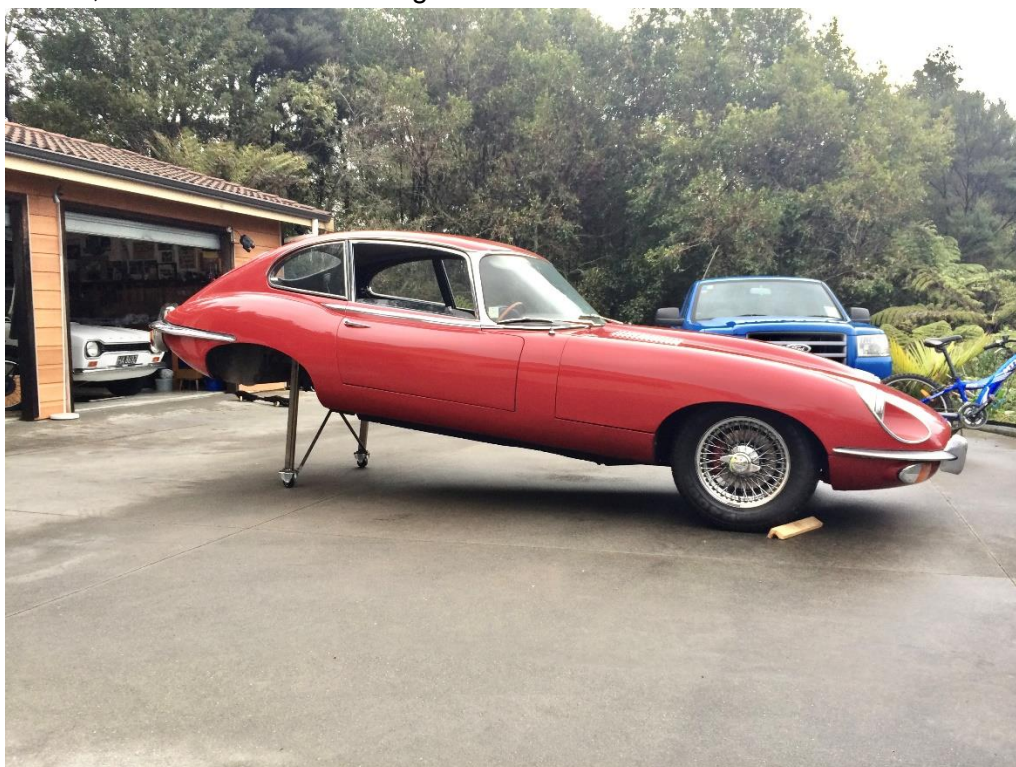
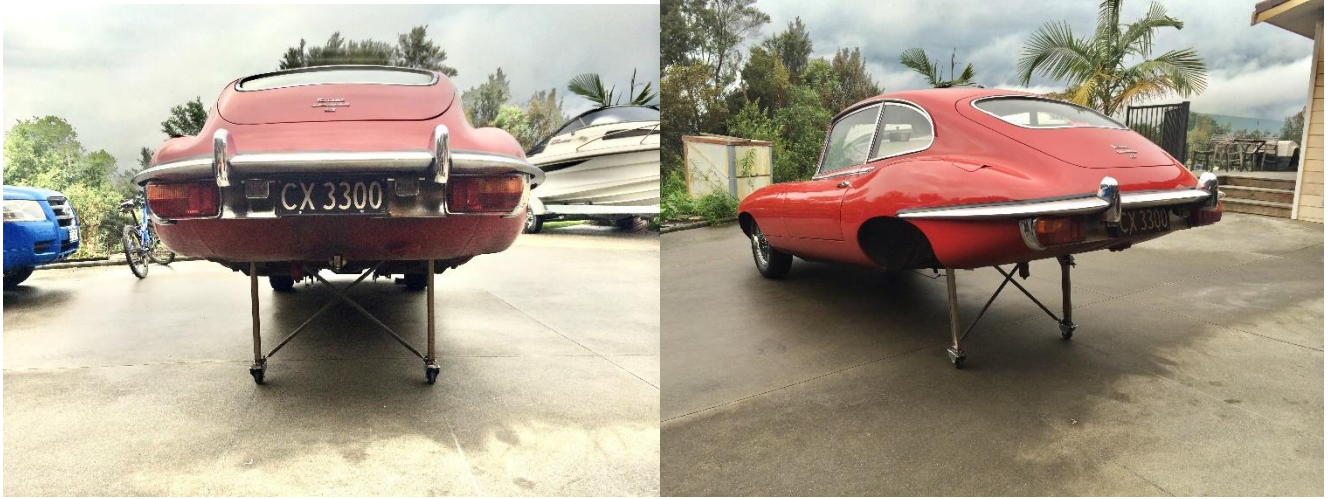
Next stage was to manufacture a trolley system that would allow the movement of the car when the IRS assembly was removed. The design brief was simple, it had to be small and unobstructive, but strong enough to be safe... well kind of! Also, high enough to allow me to climb under and around it for cleaning and painting. A quick rummage through a few garage cupboards and under the house, all the required materials were sourced. Some cutting, welding, and drilling, and with a spare set of rear wheels, we had made something that would work.

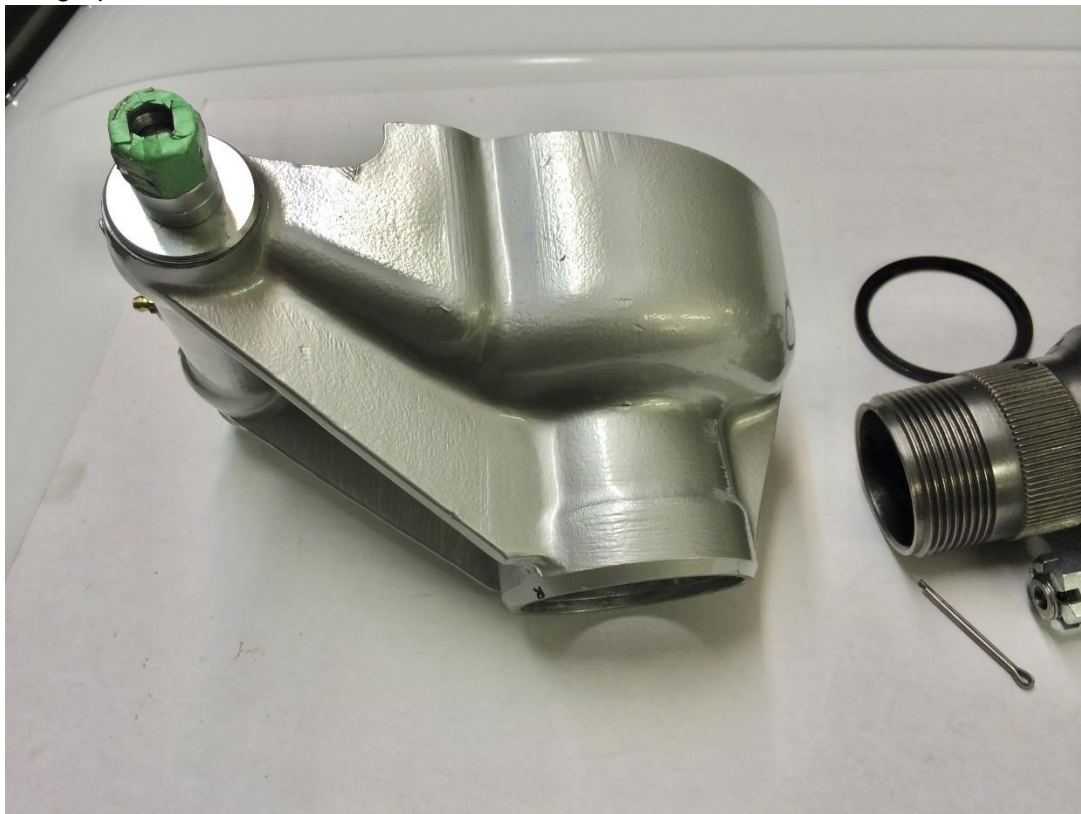
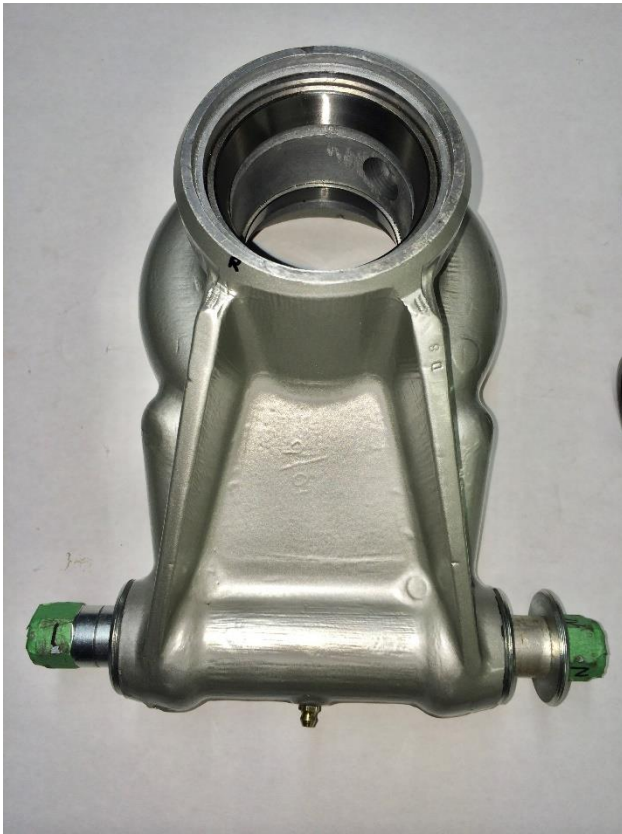
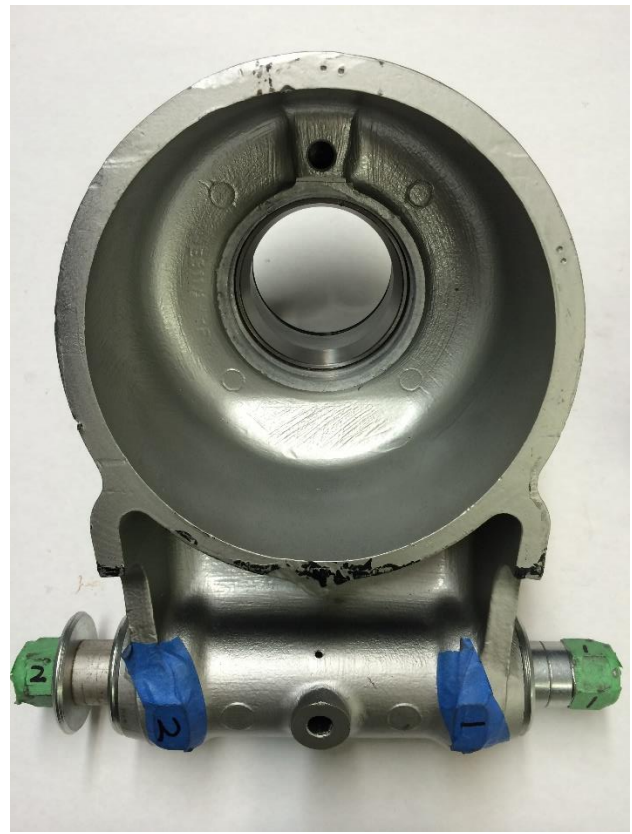
Once all the components were removed from the main cross-member they were all identified as left or right, front or rear, then stripped and cleaned. Shims and spacers were carefully removed, identified and photographed for future reference.

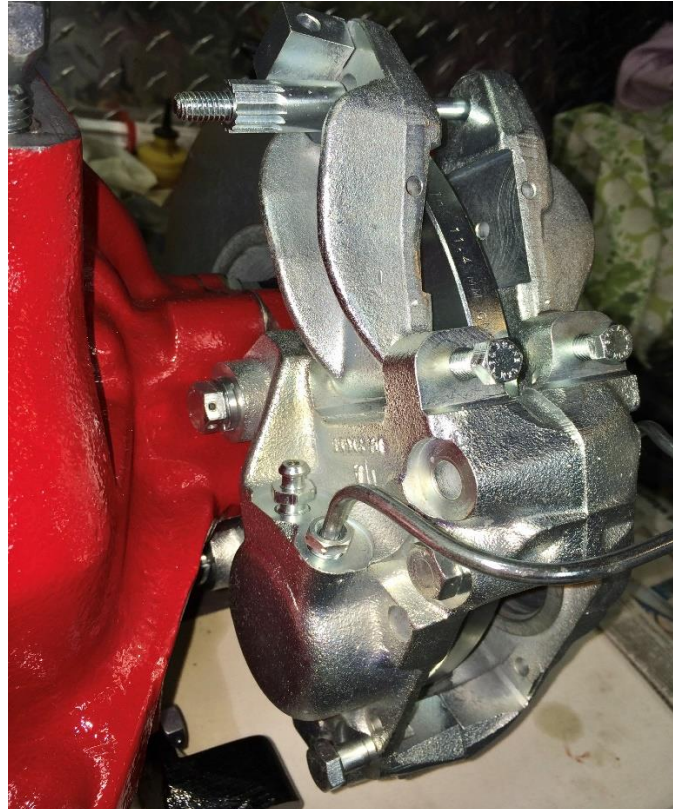
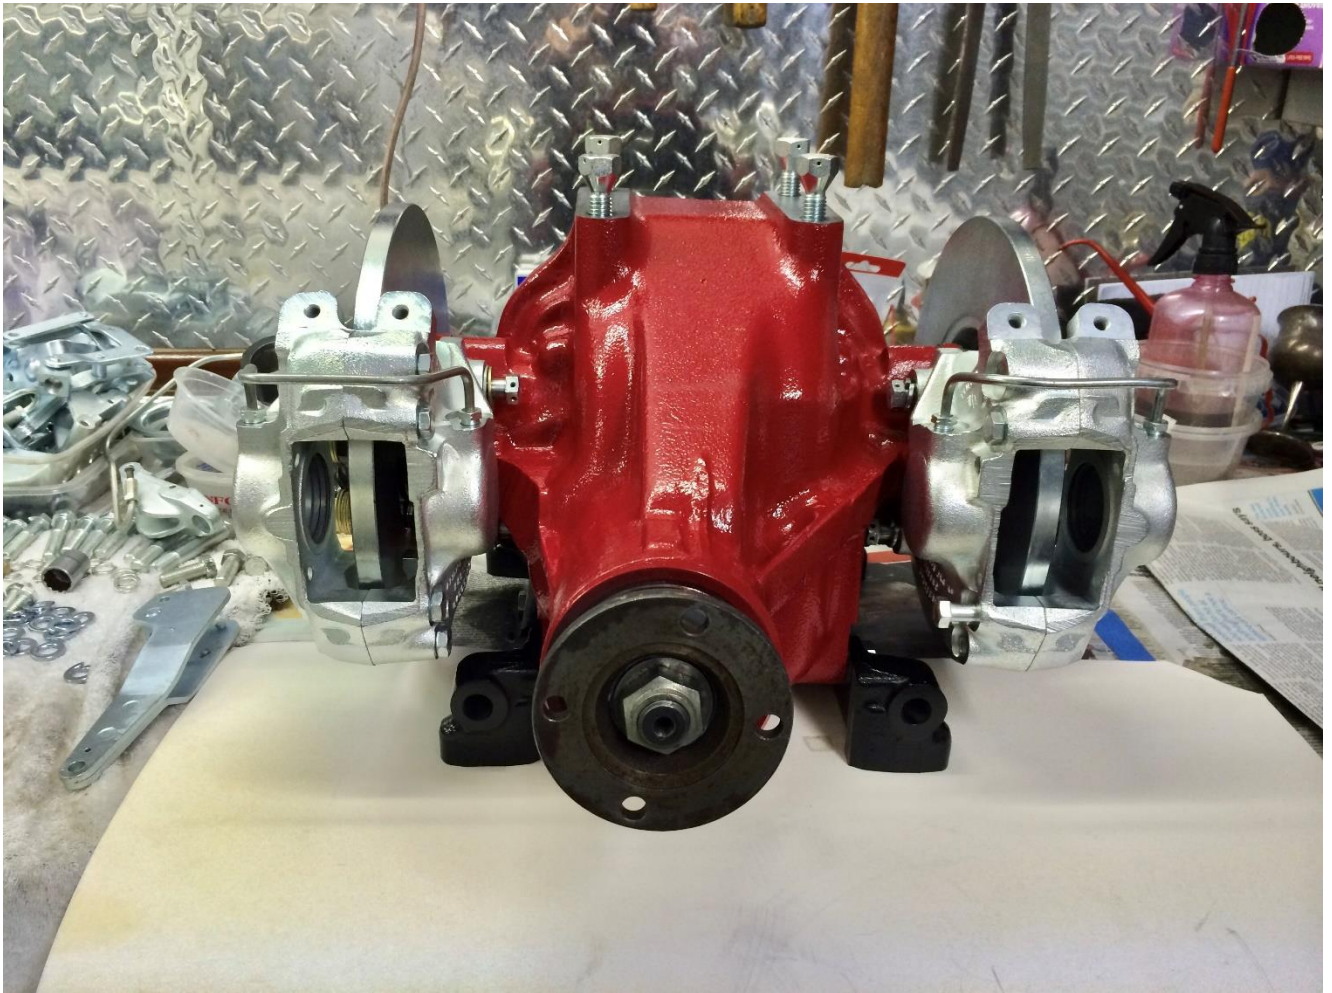
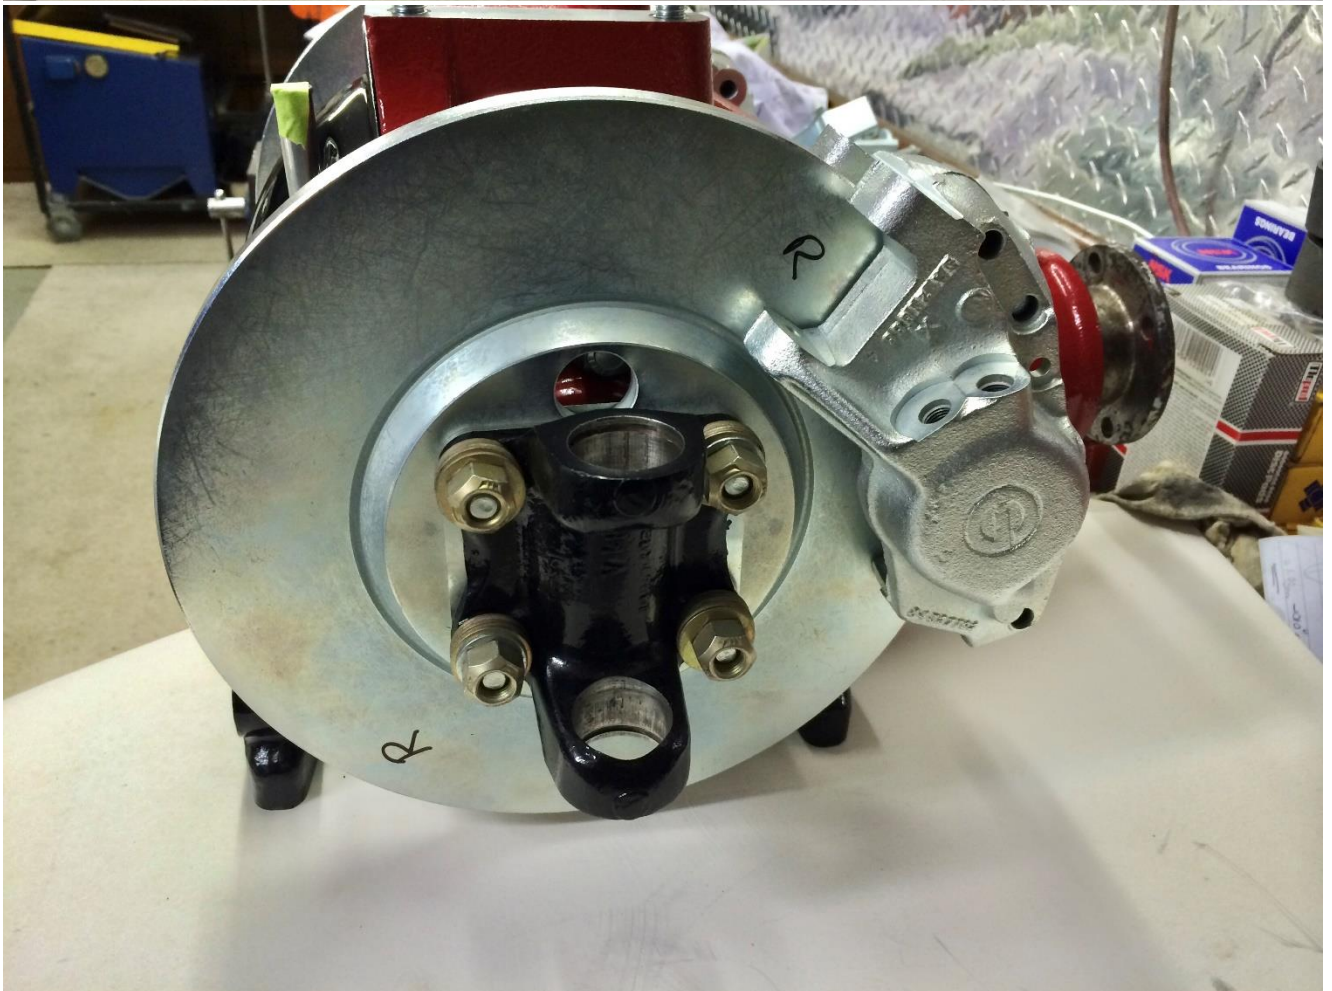
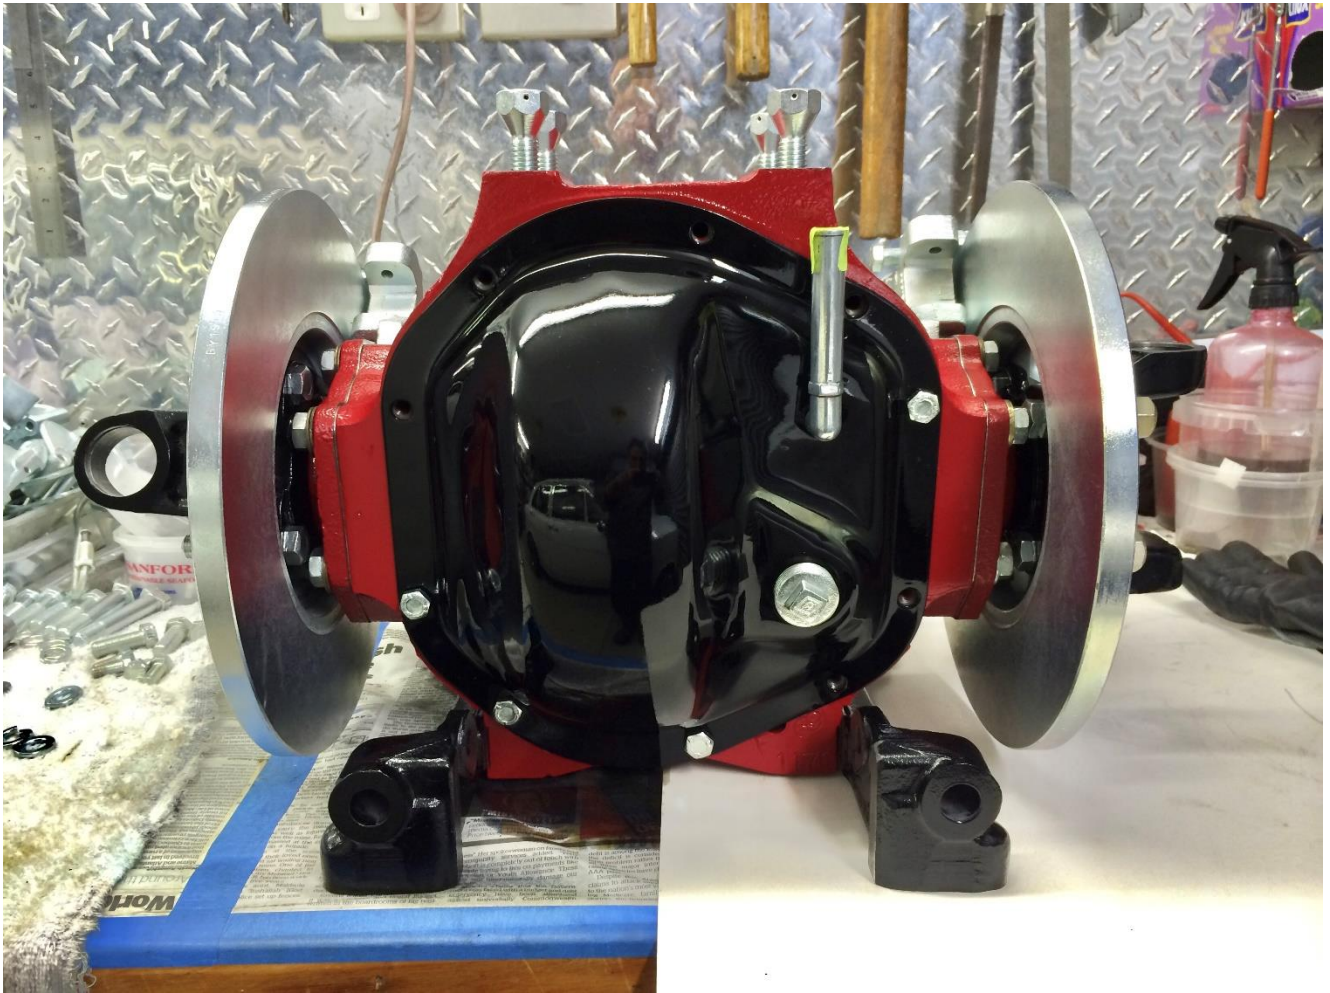
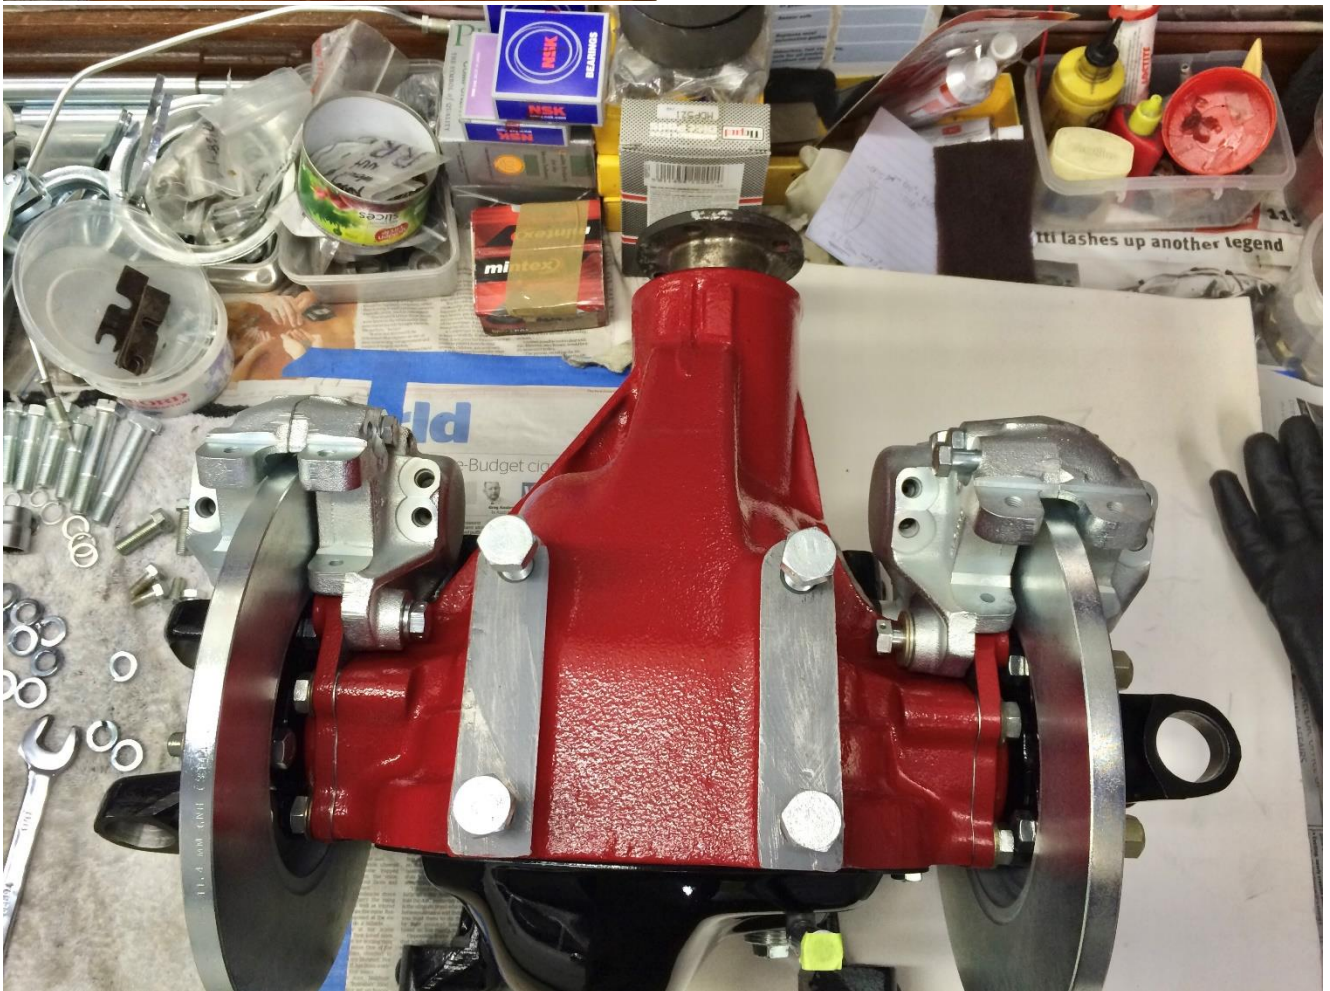
All bearings, rollers bearings, seals, rubber bushings and mounts, and brake cylinder kits were replaced with the help of the Daimler and Jaguar spares club and Auckland Bearings. All special bolts, shims, spacers, thrust washers and brake callipers were plated and all fastenings replaced. The same gloss black and red two pack paint was used as with the engine bay.

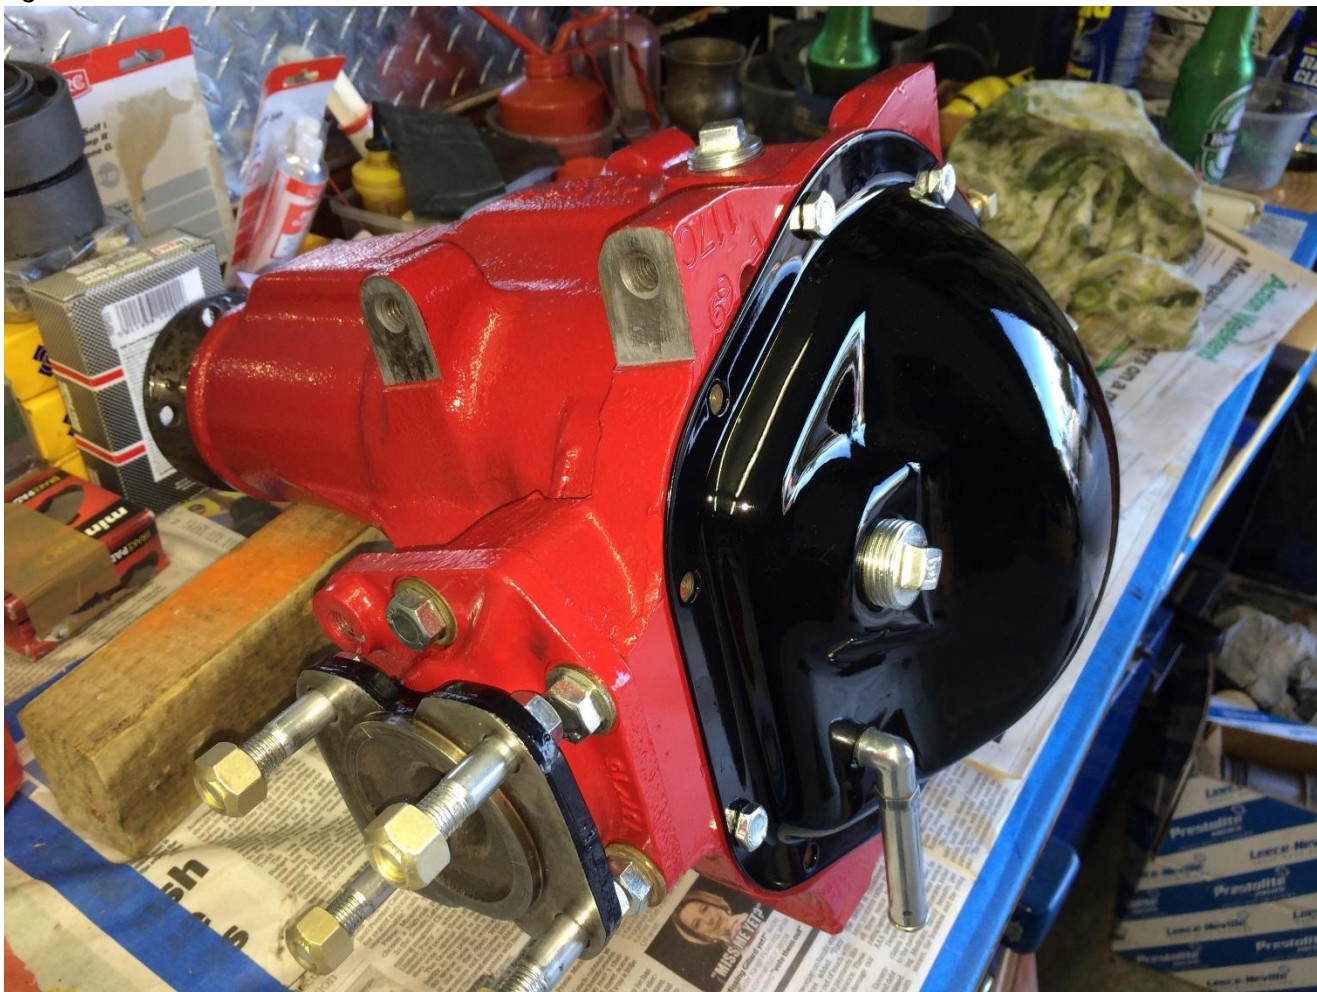
A new dilemma was encountered when I removed the diff head gear cover. I was looking forward to seeing the workings of an LSD for the first time as I had never had a car with one before. But alas, this was not to be. For some reason the diff head had been changed out to a conventional unit, most likely an XJ6 of similar vintage. After struggling to find an LSD replacement, I decided to continue with what I had. So, I sent the now cleaned unit to Bygone Autos for the setting up of the crown wheel and pinion backlash with new bearings, and to see if we could quieten it a little. Unfortunately, it went back into song around 60 mph which was rather disappointing, but maybe a sign it was showing its age.

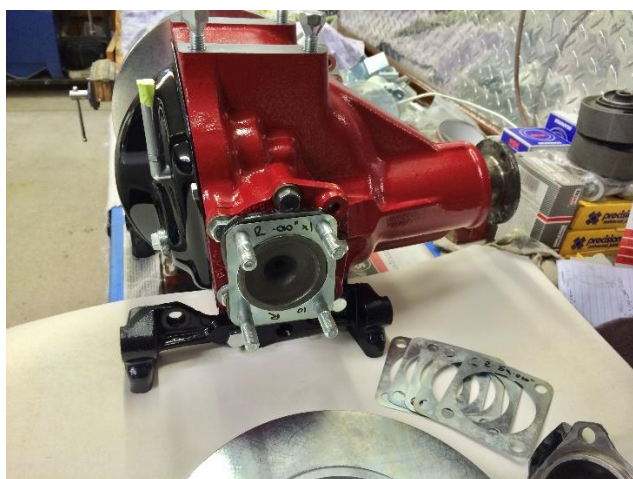
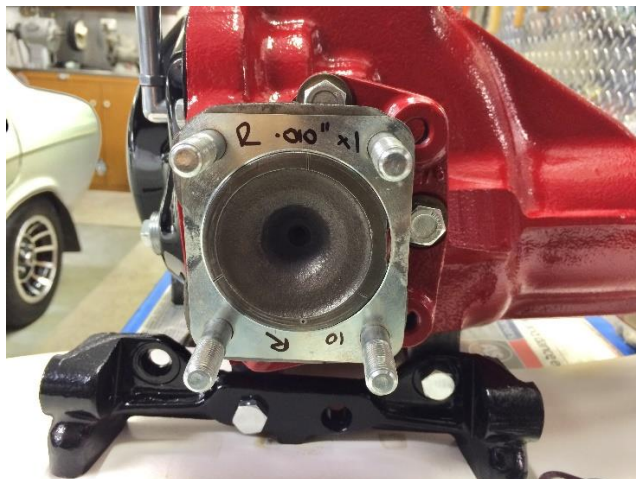
Next the two output shafts with new bearings could be fitted to the diff head followed by two new brake rotors and the rebuilt brake callipers. This was then mounted back into the main crossmember.

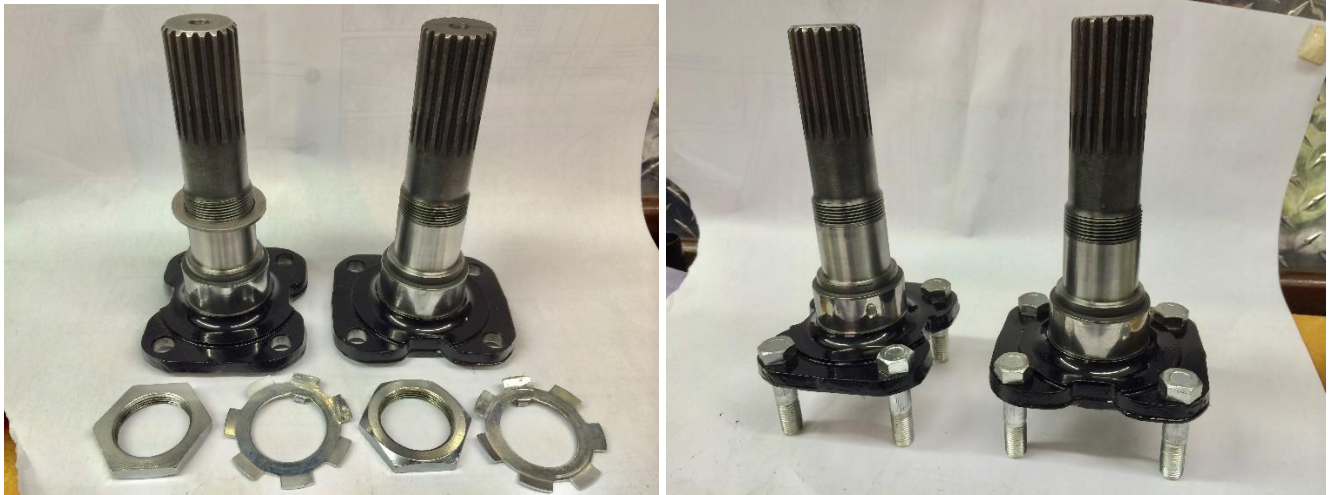
Four new universal bearing cap sets were fitted to both half shafts, then bolted to the rotor flange with the corresponding number of newly plated shims for adjusting the rear wheel camber.

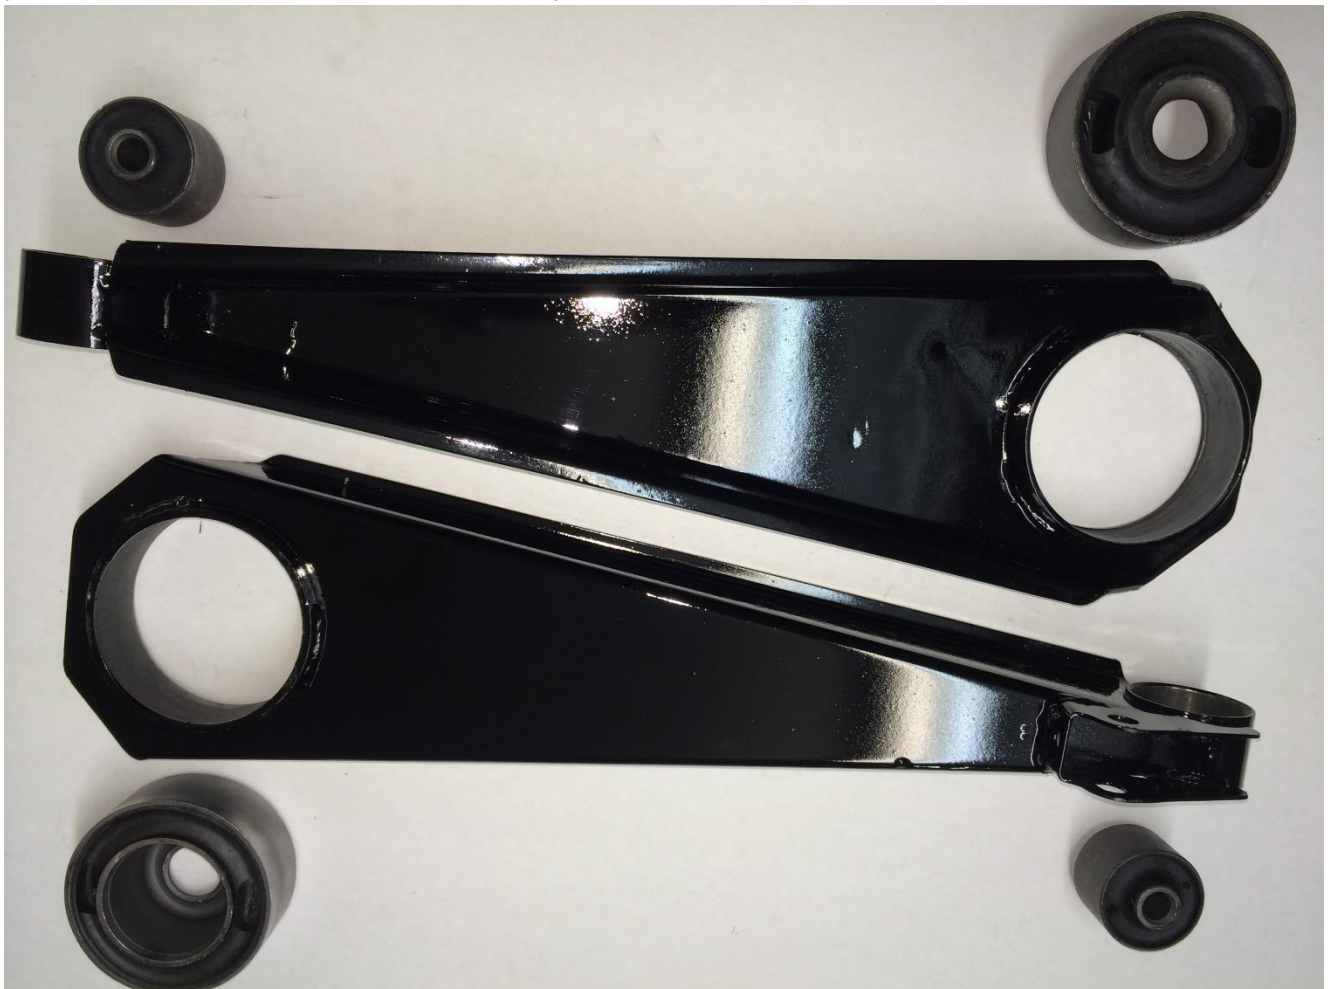
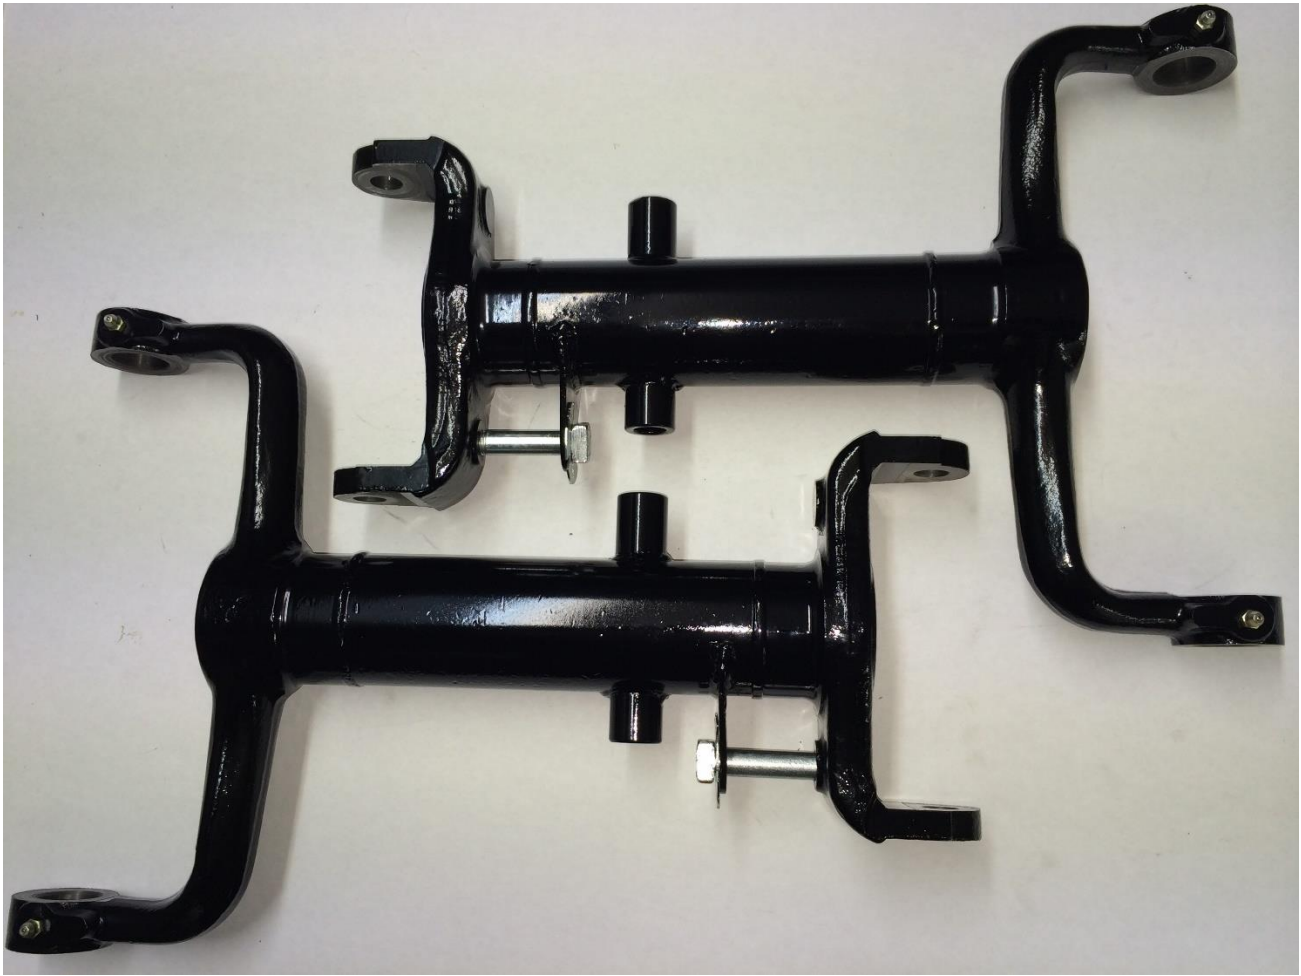
Next the installation of the two wishbones. There is a lot going on with the design of these wishbones and their associated fulcrum shafts. Over 40 individual components make up this very complex swing arm system. Throughout the assembly I used a high-quality marine saltwater grease for packing all the bearings and lubrication for all the moving parts, seals and thrusts. This stuff is brilliant and 10 years later it is still at the same consistency.

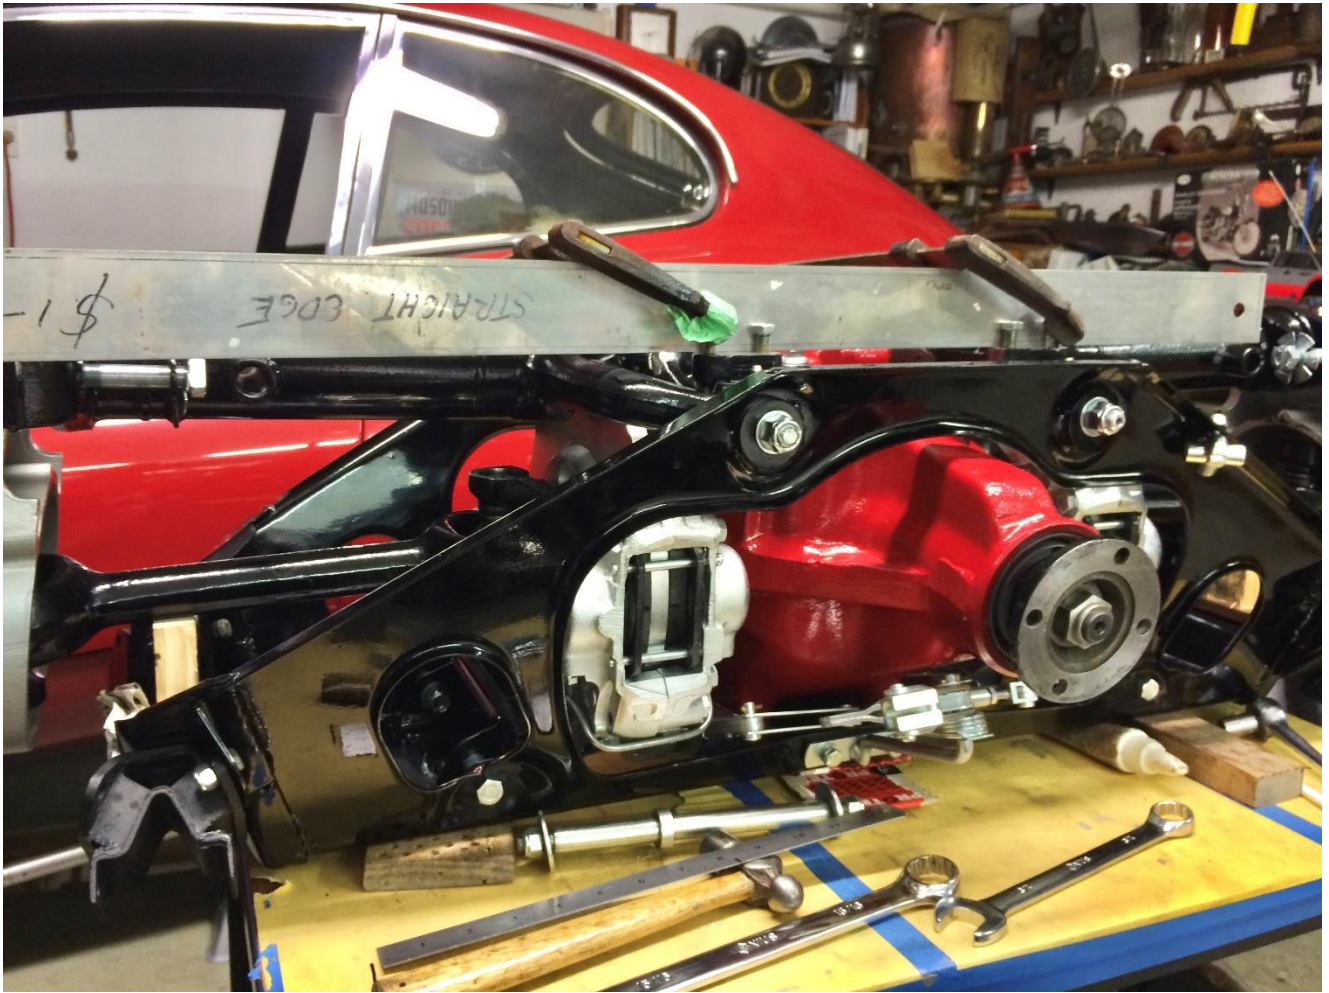
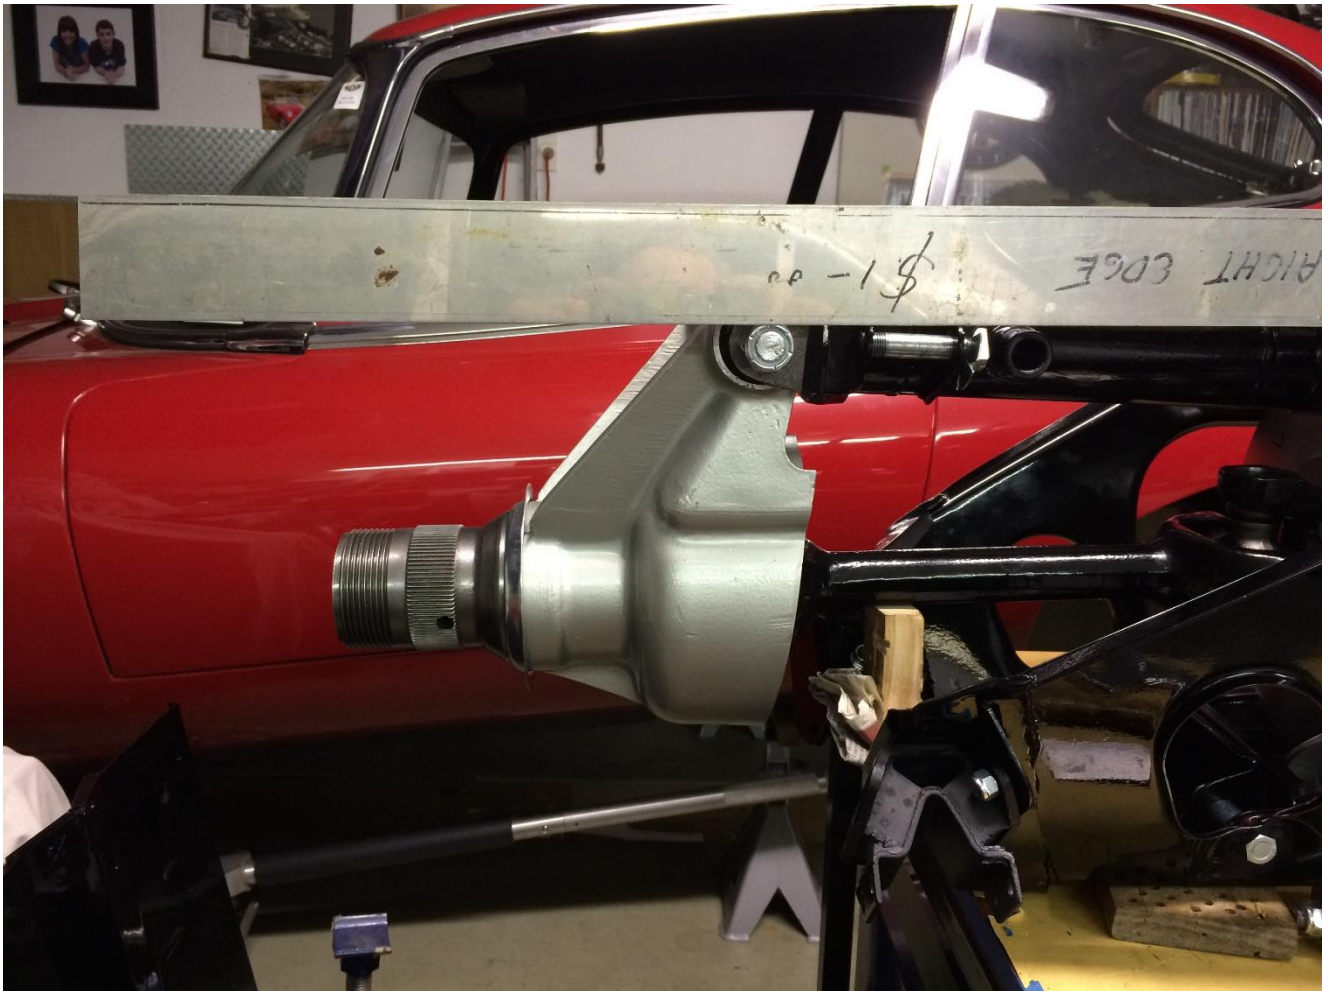
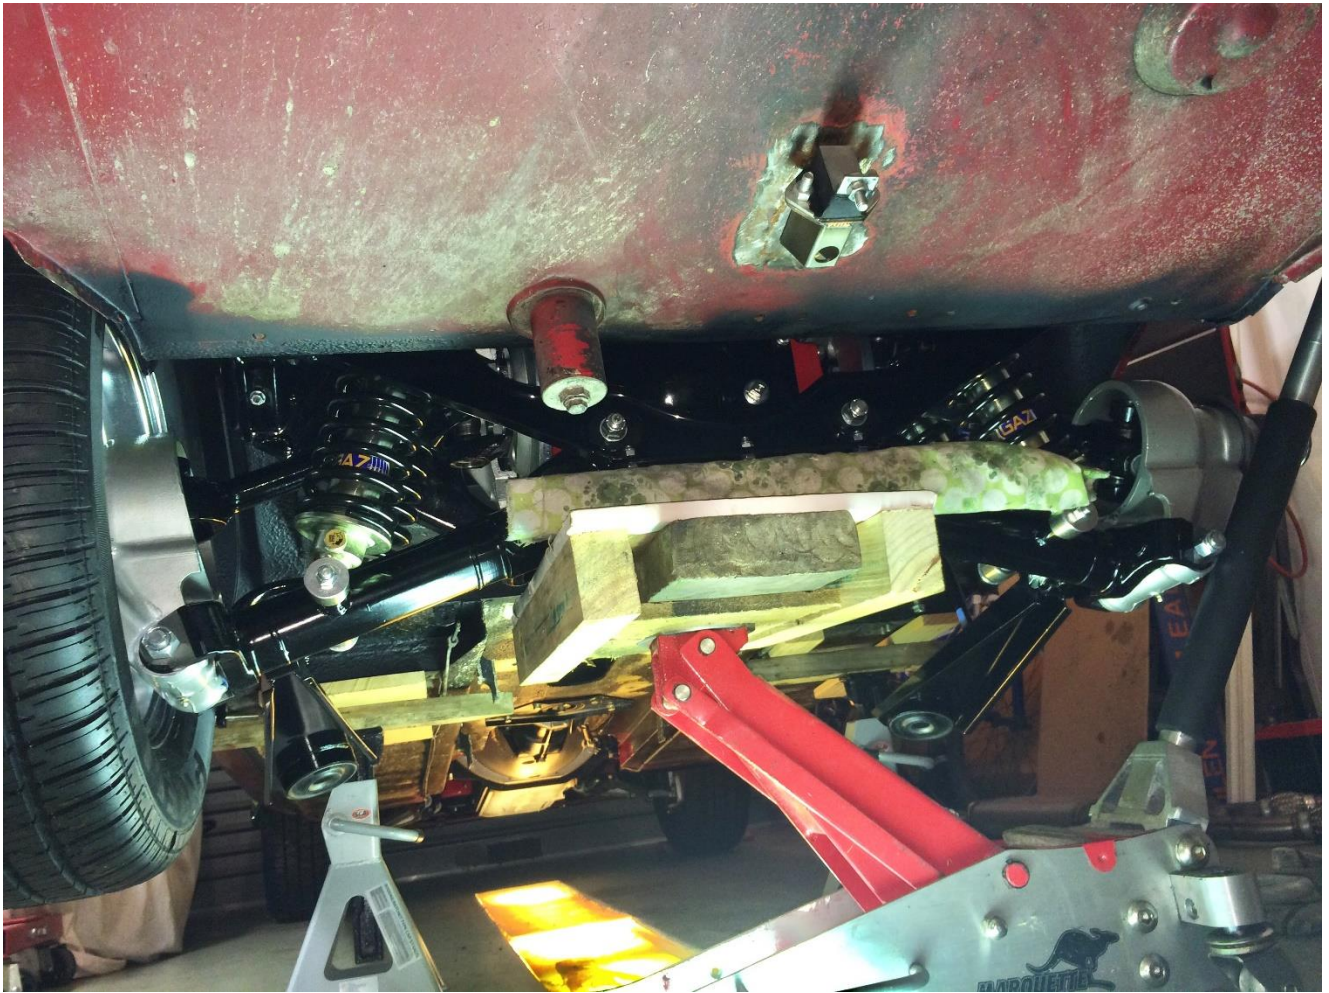
With the main crossmember complete and, after a photo shoot (which I can't find), it was time to lift the whole assembly back into position to the freshly prepared underbody and connect the tail shaft, hydraulic brake line, hand brake cable and road test.
