Early 3.8 E Type petrol leak!

Simon Crispe

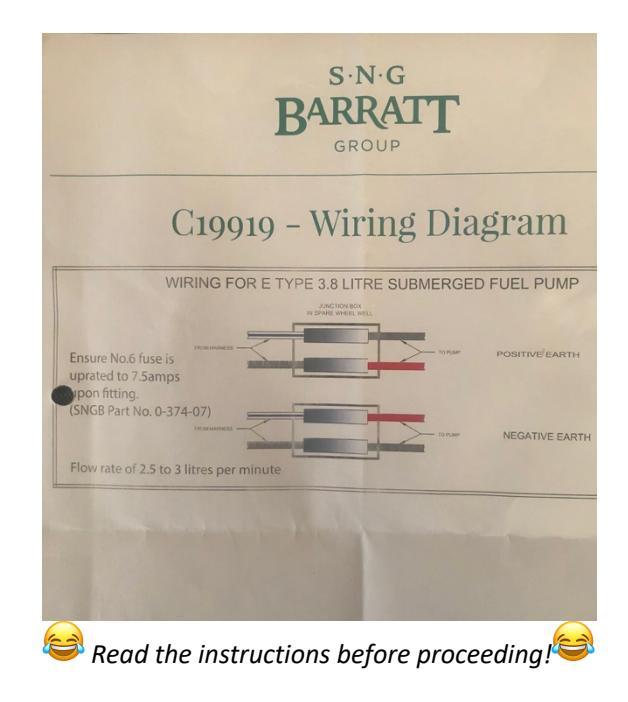
There it was in black and white... "Ensure No. 6 fuse is uprated to 7.5A upon fitting" (i.e 7.5amps continuous /15amps blow).

Clearly the new pump draws more current"!!

I then opened the centre dash to check the fuses and sure enough the original 5A fuse had blown. I replaced it with one of the 15A spares stored in the fuse block and we were back in business. The engine started instantly and we were off down the Tamaki Drive.
